Poors Allotment Charity
c/o 1 Snelsmore Farm Cottages
Snelsmore
NEWBURY
RG14 3BU

West Berkshire Council as Lead Local Flood Authority
Council Offices,
Market Street
Newbury
RG14 5LD

6th March 2022

We are currently faced with two issues at the Parish Field in Enborne . There is a long running issue with drainage of water from the Parish Field onto the Spring Gardens Estate. The other issue centres on the objections of some Spring Gardens residents to Calleva's proposals to build a solar farm in the Parish Field. The two issues have become conflated.

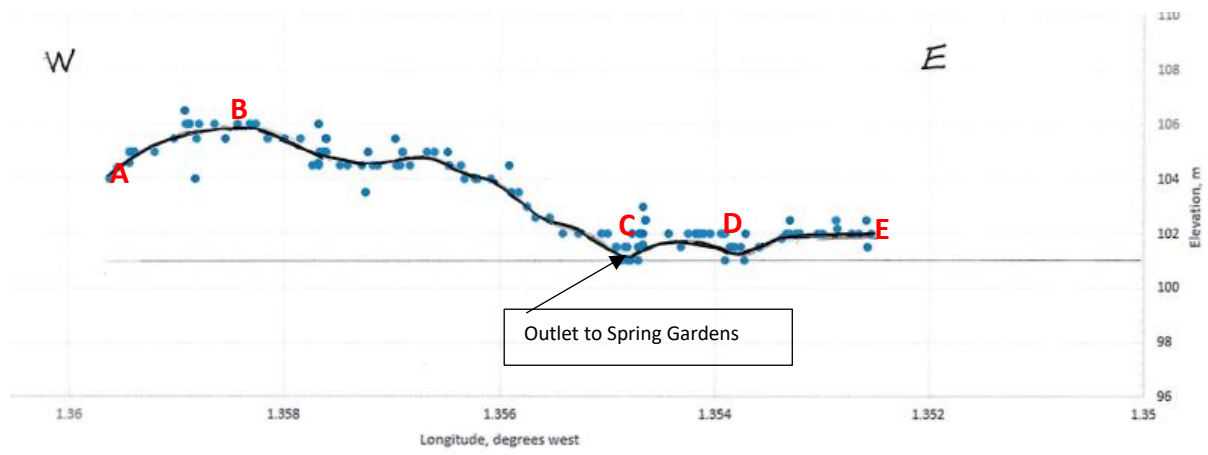
The height profile of the southern field boundary is shown in Figure 2 and can also be inferred from the contour map in Figure 1. The height profile was produced by the trustees by walking the southern field boundary with a hand-held GPS. Both the map and the profile show clearly that the land rises both west from and east from the SGU (point C). By more than 2m to the west and by almost 1m to the east.

Figure 2. Height profile of the southern boundary of the Parish Field and DEFRA Magic Map of Property Boundaries. GPS height and location data recorded by John Leeson 30 Jan -1st Feb 2022

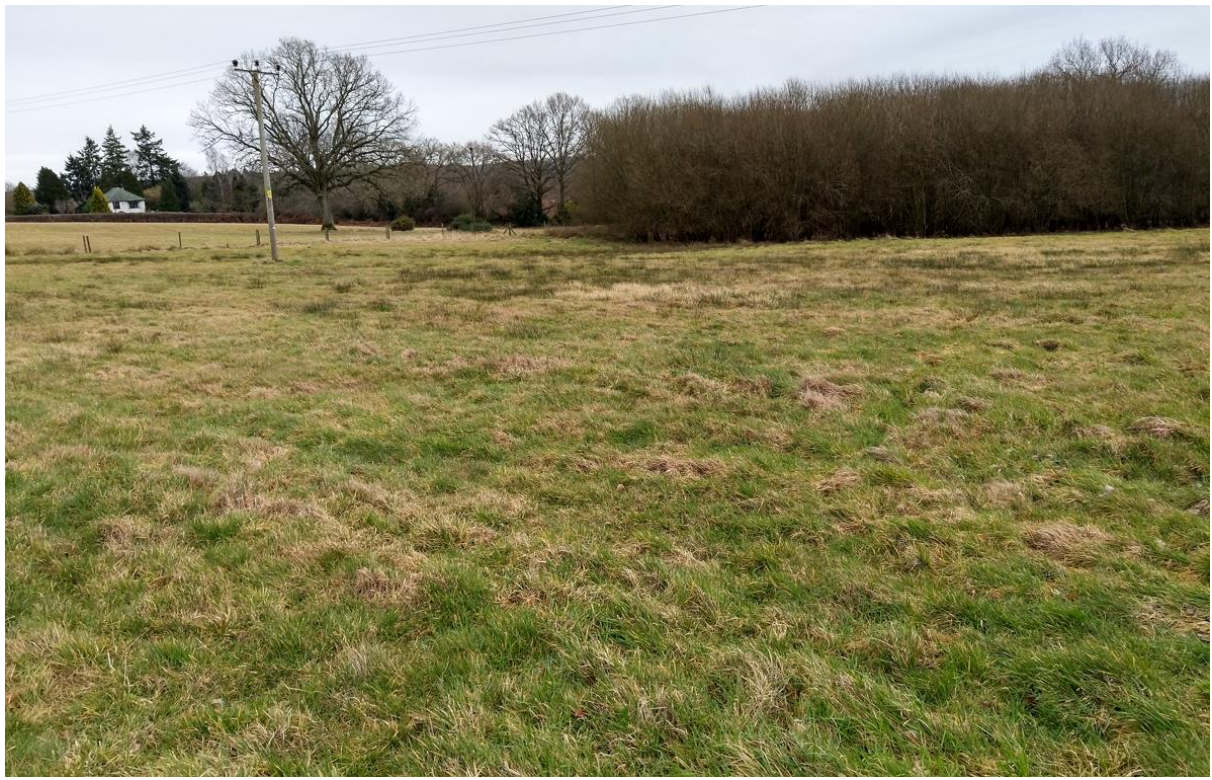
Figure 3. Spring Gardens Undulation from the north. The undulation is characterised by dark green spiky grass and a goat willow copse associated with waterlogged ground.

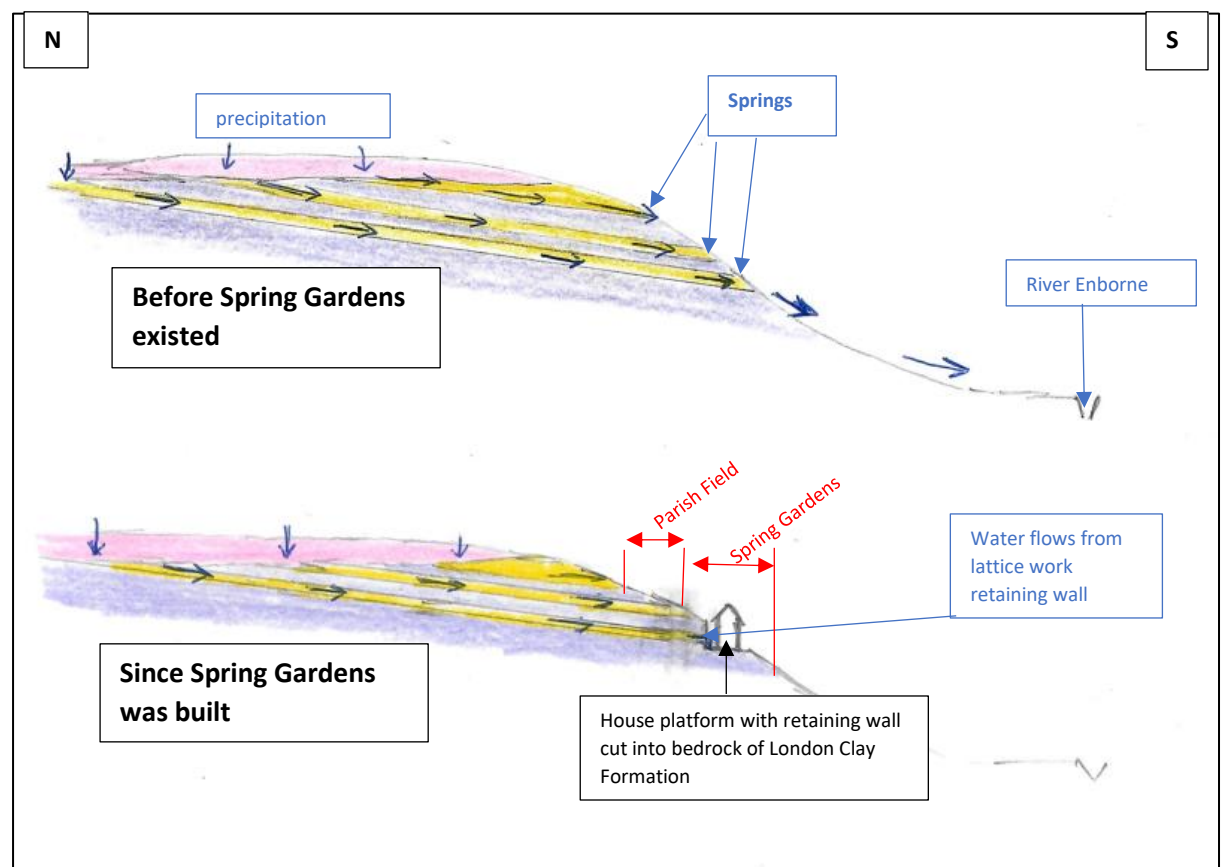
We would expect the clay layers to be impermeable, the sandy layers and particularly the pebble layers should be permeable and a potential channel for groundwater flow provided they can be charged somewhere up dip/up slope. Figure 7 is a cross-section showing the geological situation at the Parish Field and Spring Gardens. The overlying Silchester Gravels are permeable and allow precipitation to percolate down onto the underlying London Clay Formation. The water is able to enter permeable sand and pebble layers in the London Clay formation to emerge in the Parish Field or Spring Gardens. Where the water percolating down through the Silchester gravel encounters clay the water flows across the impermeable upper surface of the clay, following the topography of the clay surface. At the Parish Field and Spring Gardens the SGU concentrates the surface water and any spring water into a small intermittent trickle that passes from the Parish Field into Spring Gardens.

Figure 7, Schematic Cross Section, N to S across the Parish Field and Spring Gardens. Not to scale and with vertical exaggeration.

Before the Spring Gardens estate was built the trickle of water was further supplemented by more spring water that emerges within the field (now Spring Gardens) as illustrated in Figure 7, upper

diagram. This resulted in a very boggy field. The farmer who used to rent the Spring Gardens field from Mrs Rooke, a former owner, for grazing cattle attests that the field was always extremely boggy, to the extent that a tractor could become stuck. The lower cross section in Figure 7 shows the likely current situation and may explain why water flows from retaining walls behind the houses on the north side of Spring Gardens road

When the Spring Gardens estate was built the developer cut platforms into the natural slope to create horizontal slabs onto which to build houses. This created a near vertical bank behind the houses of a meter or two in height. Older residents of Enborne Row attest that water was seen running out of this steep bank after it was cut. The likely source of this water is a sand or pebble layer in the London Clay charged from somewhere upslope, see Figure 7.

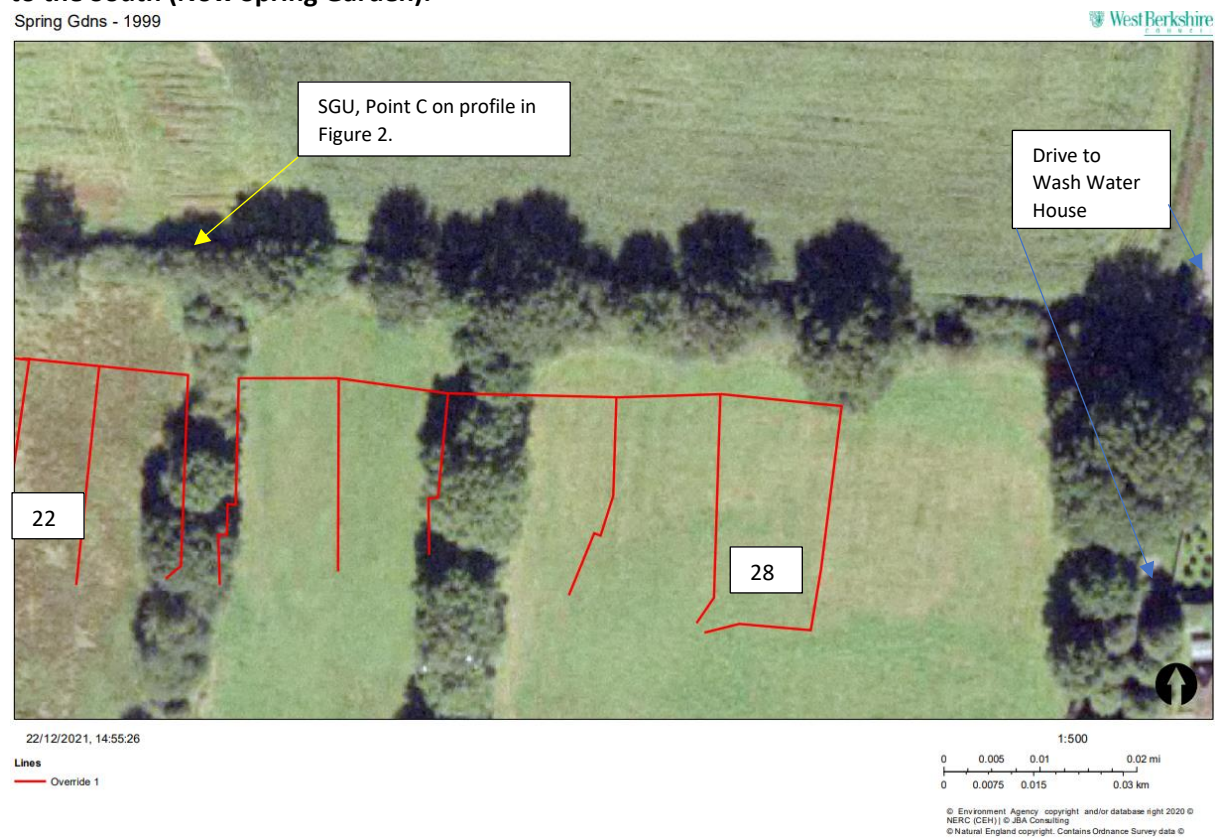
Figure 8 is a satellite download from 1999, before the estate was built. The resolution is not great and it was obviously taken in the summer. The shadows from the trees indicate the satellite image was taken near midday, as the trees cast a shadow to the north. The boundary bund along the edge of the Parish Field is clear to see at two places where there are no trees. Given that there is no shadow associated with a ditch wall or significant mound I conclude the earthwork is not deep enough to have been a drainage ditch that allowed water to flow from west to east.

Superimposed on the satellite image are the boundaries of Spring Garden’s properties 22 to 28. This satellite image with the superimposed plot boundaries was kindly supplied by WBC.

Figure 8, 1999 Satellite Image of the South East Corner of the Parish Field and the Adjacent Fields to the South (Now Spring Garden).

We do not know when these contour parallel trenches were dug or by whom. We do know that they are not visible or distinguishable in the satellite image from 1999, Figure 8, which also shows that there was no copse of goat willow in 1999.

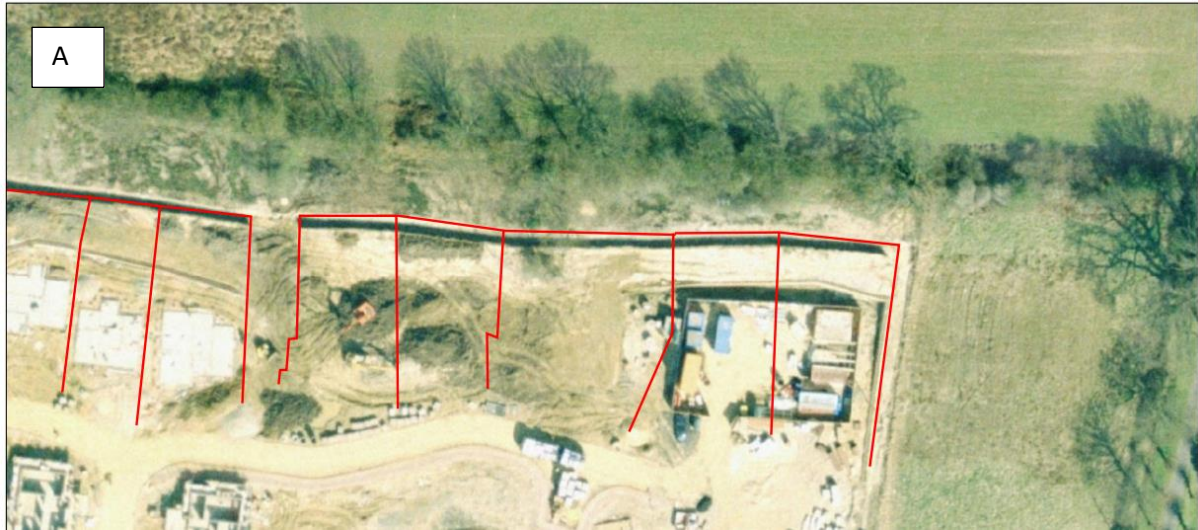
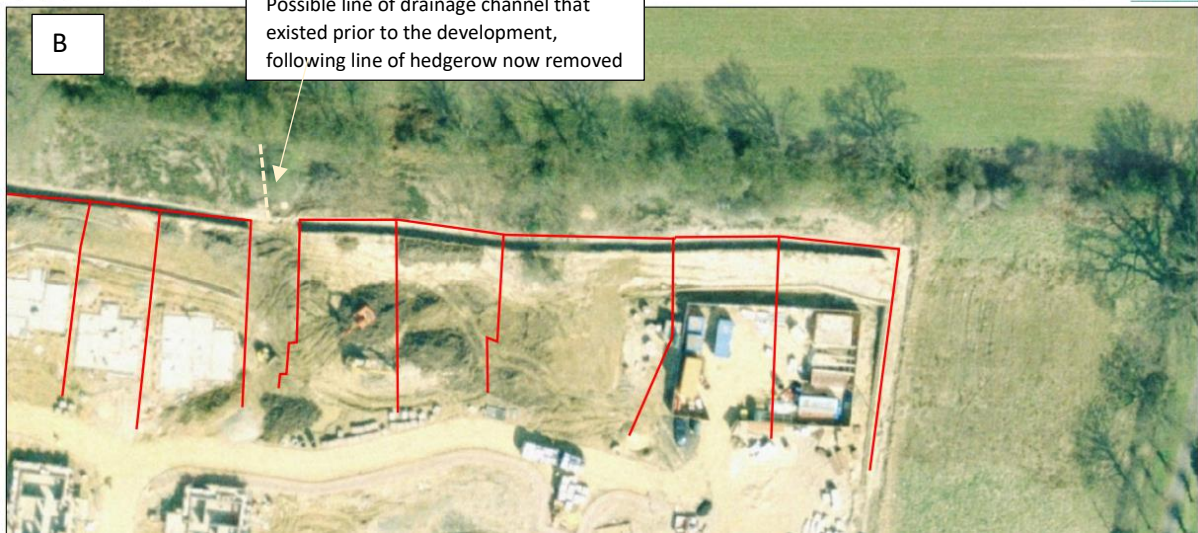
Figure 11 is a satellite image taken in 2003 during the construction phase of Spring Gardens. This can be interpreted to show the line of the drainage channel that was running down the old hedgerow. This drainage channel directs water towards "the access path", which was to allow access to a common access area running west to east behind the Spring Gardens properties. We have been told by a representative of WBC that the planners insisted on this access path and that it was regarded as an outflow route for any excess water. This seems likely as the access path largely follows the route of the old drainage channel and hedgerow and the Environment Agency Map area at flood risk, Figure 4..

Figure 11. Satellite Image of Spring Gardens During Construction, Image B with added interpretation.

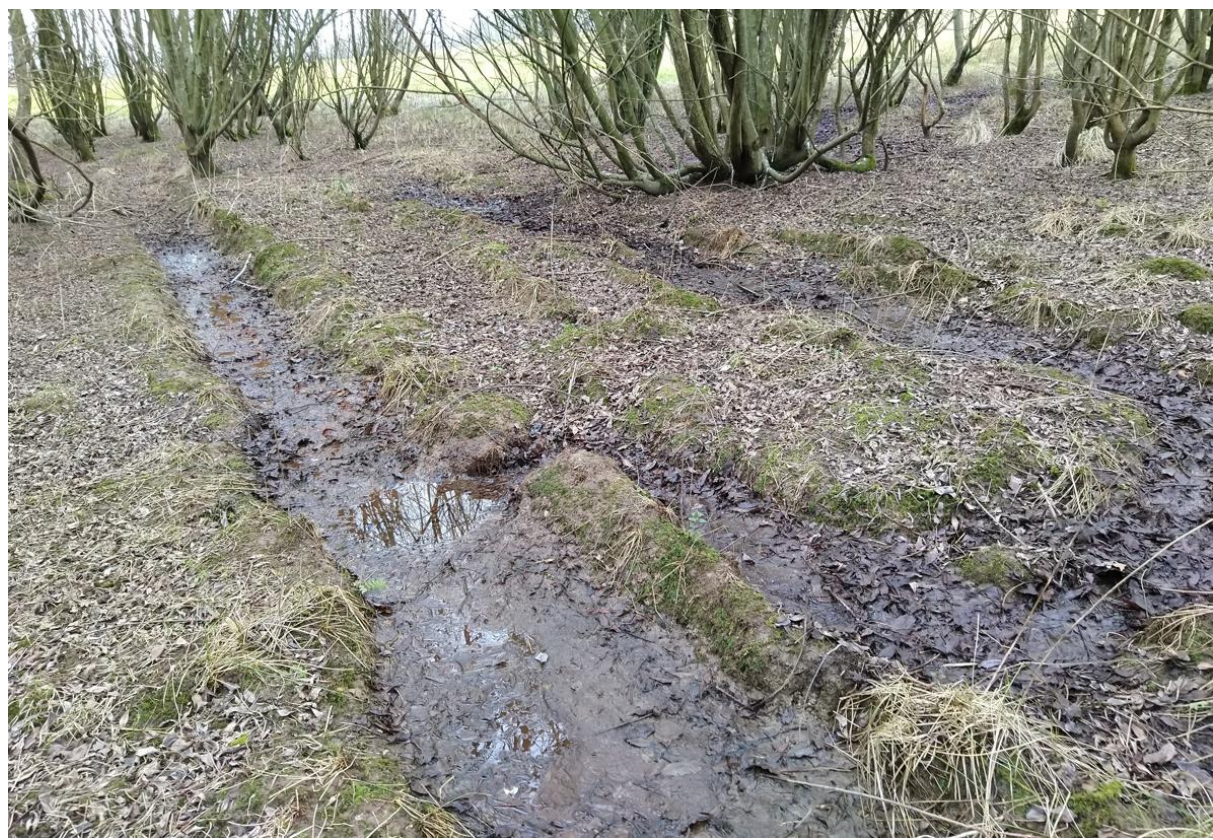
Other earthworks are visible within the Parish Field within the SGU. There are a series of shallow contour parallel trenches within the copse of goat willow trees which presumably act to attenuate flow down the slope. Figure 13.

Figure 13, Contour Parallel Trenches in the Goat Willow Copse of the Spring Gardens Undulation

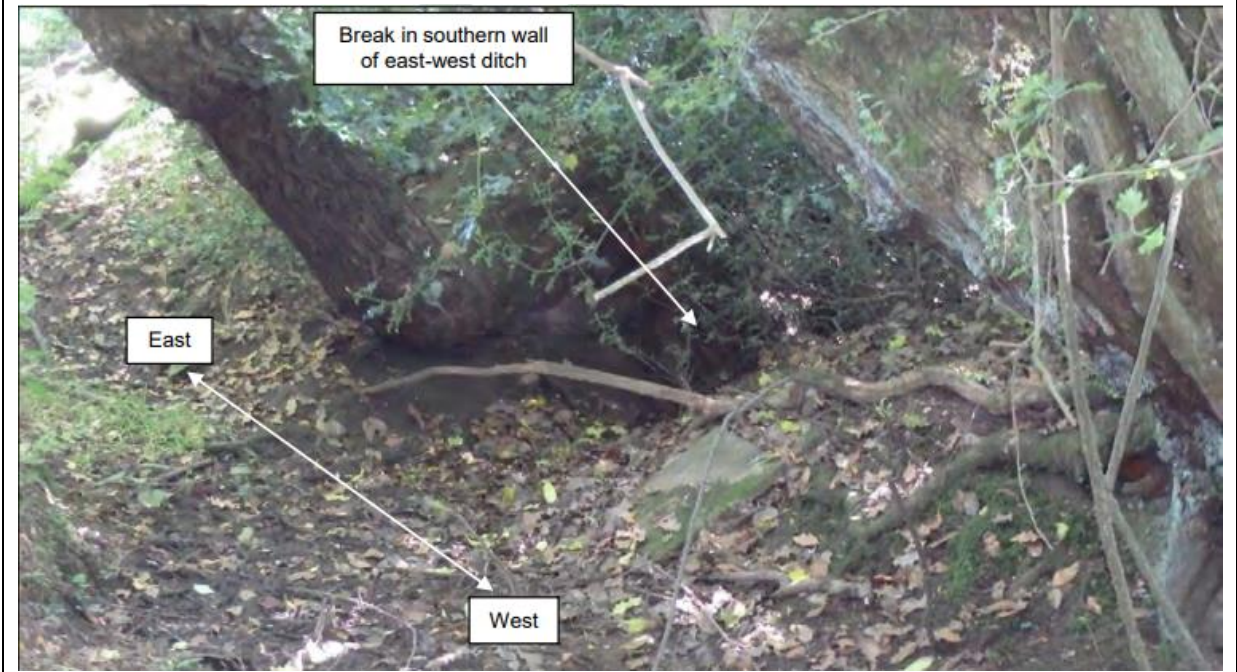
It is clear that someone has been accessing the Parish Field and digging out the boundary mound/ditch, presumably to enhance its water attenuation capacity. This work has not been instigated by the Trustees. Figure 14 shows the outflow from the ditch in the summer 2021, located immediately west of a distinctive tree.

Figure 14, Ditch and OutFlow Channel in Summer 2021. Photo and annotation from the Lidar Logic Report dated September 2021.

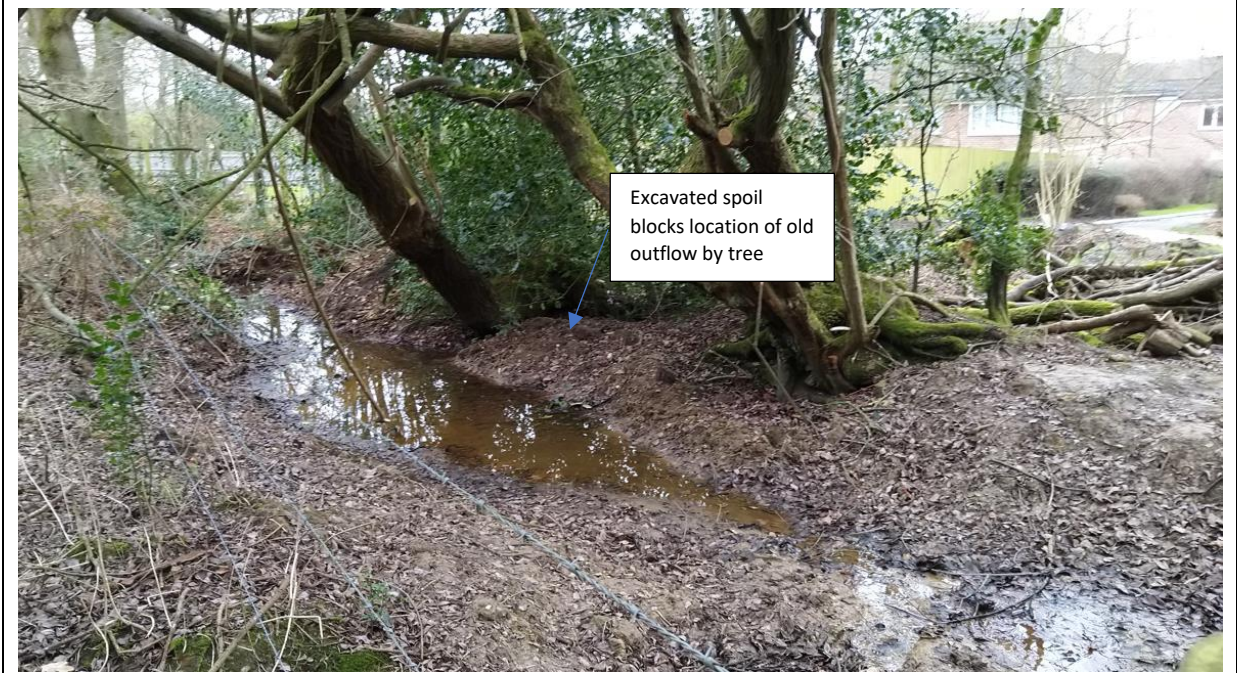
Some of the excavated spoil from the ditch has been used to block the old outflow, see Figure 15

Figure 15, Ditch February 2022. Outflow by Tree Blocked.

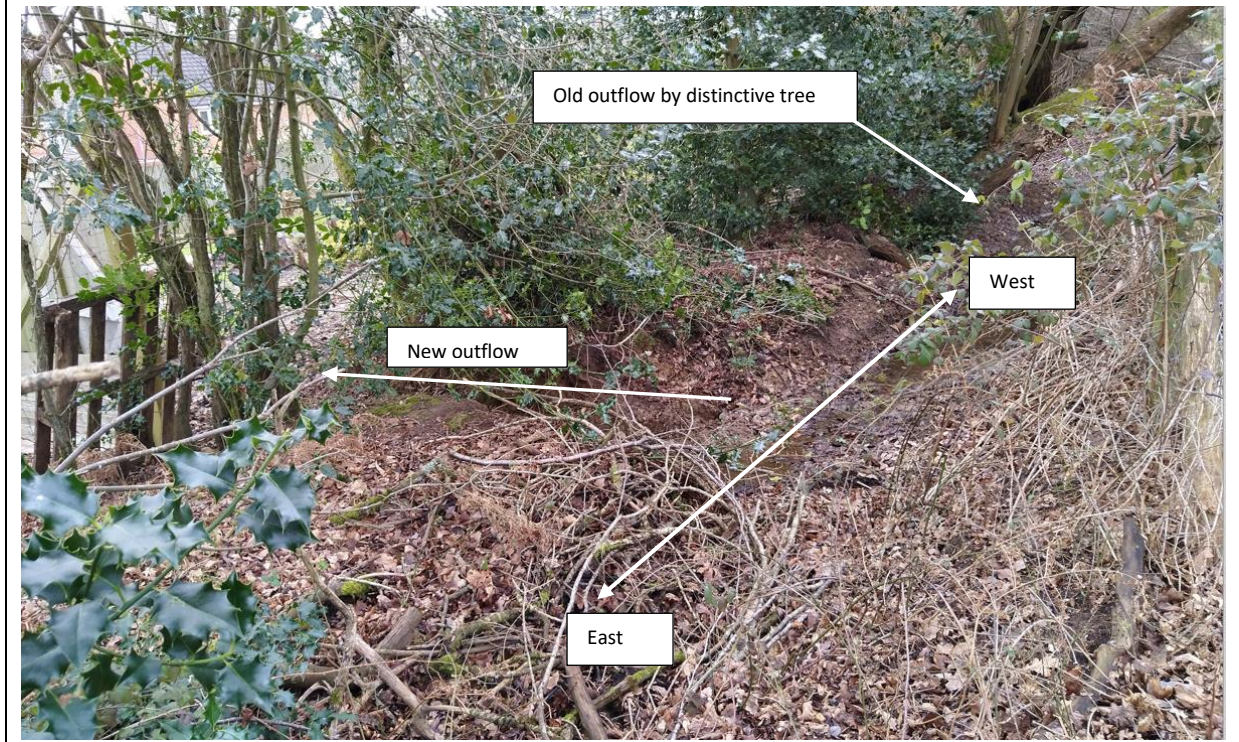
A new outflow has been dug a few meters to the east, Figure 16, transferring the outflow water to the east.

Figure 16, Latest Outflow Location, February 2022

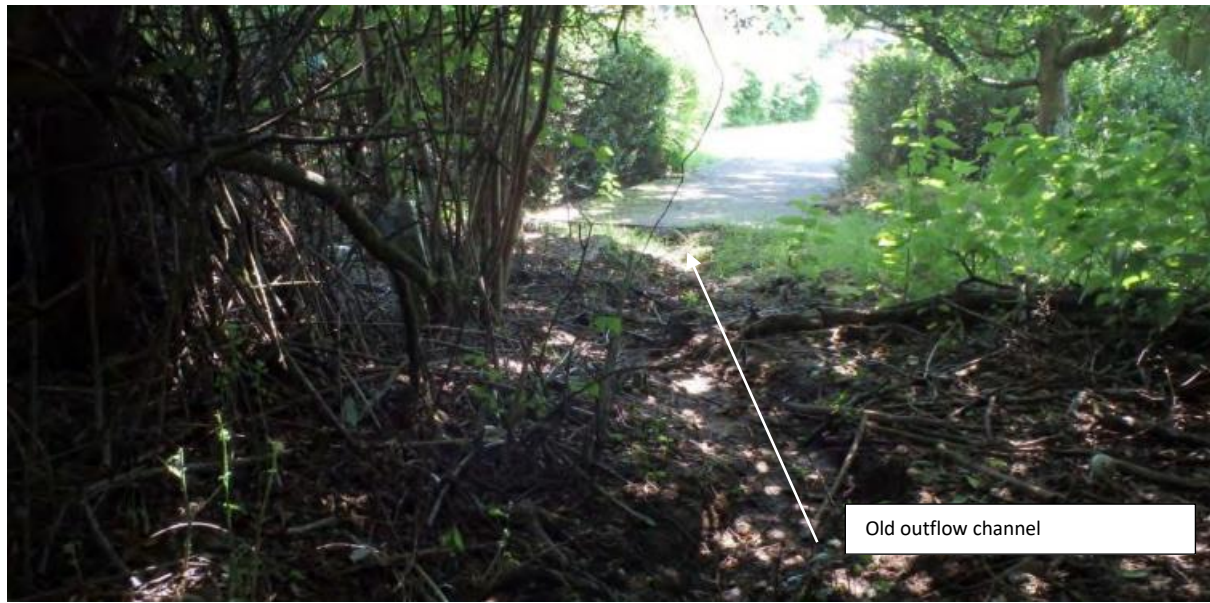
There has for some time been a problem with water from the boggy area at the top of Spring gardens flowing down the access path and out onto the Spring Gardens hardtop road, see Figures 16 and 17., which are photographs taken in the summer of 2021 and during 2016, respectively. In the winter the water on the road freezes on frosty mornings creating a safety hazard.

Figure 17, View from Outflow Channel Looking South Down the Access Path. Photo from Lidar Logic, September 2021.

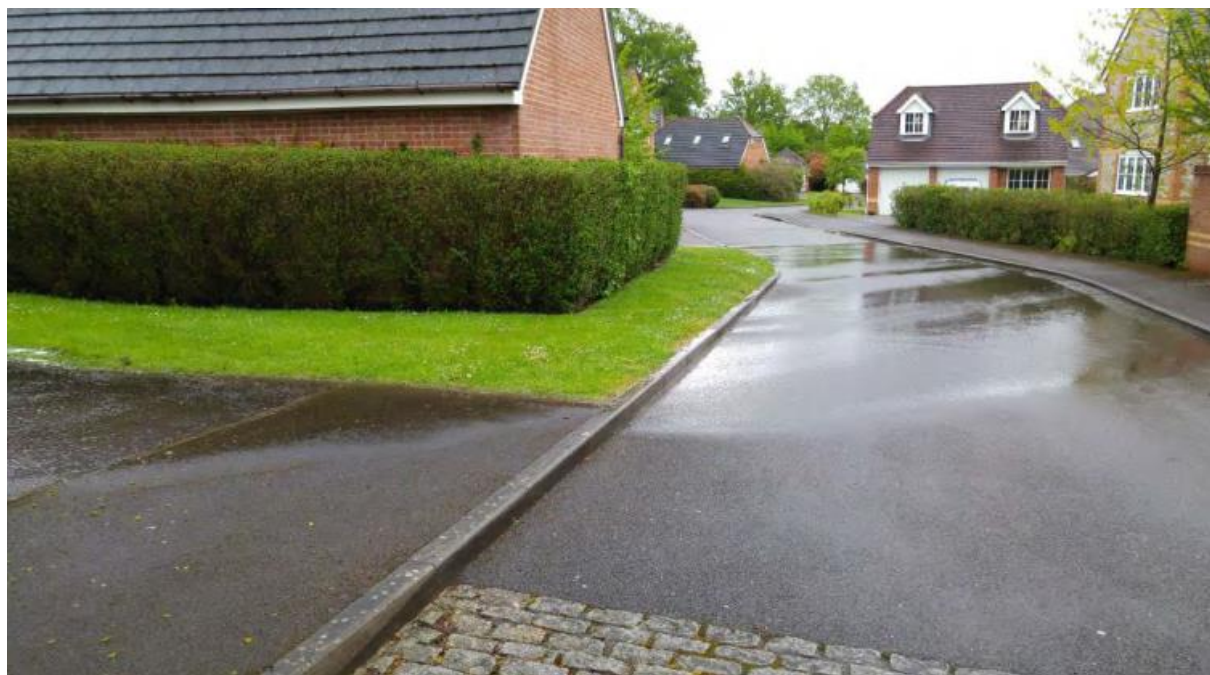
Figure 18, Water Flowing from Access Path and Across the Hardtop, 2016 from John Leeson
